# ANNUAL REPORT FOR 2002

**Long Creek Mitigation Site  
Mecklenburg County  
Project No. 8.U672204  
TIP No. R-2248**

Office of Natural Environment & Roadside Environmental Unit  
North Carolina Department of Transportation  
December 2002

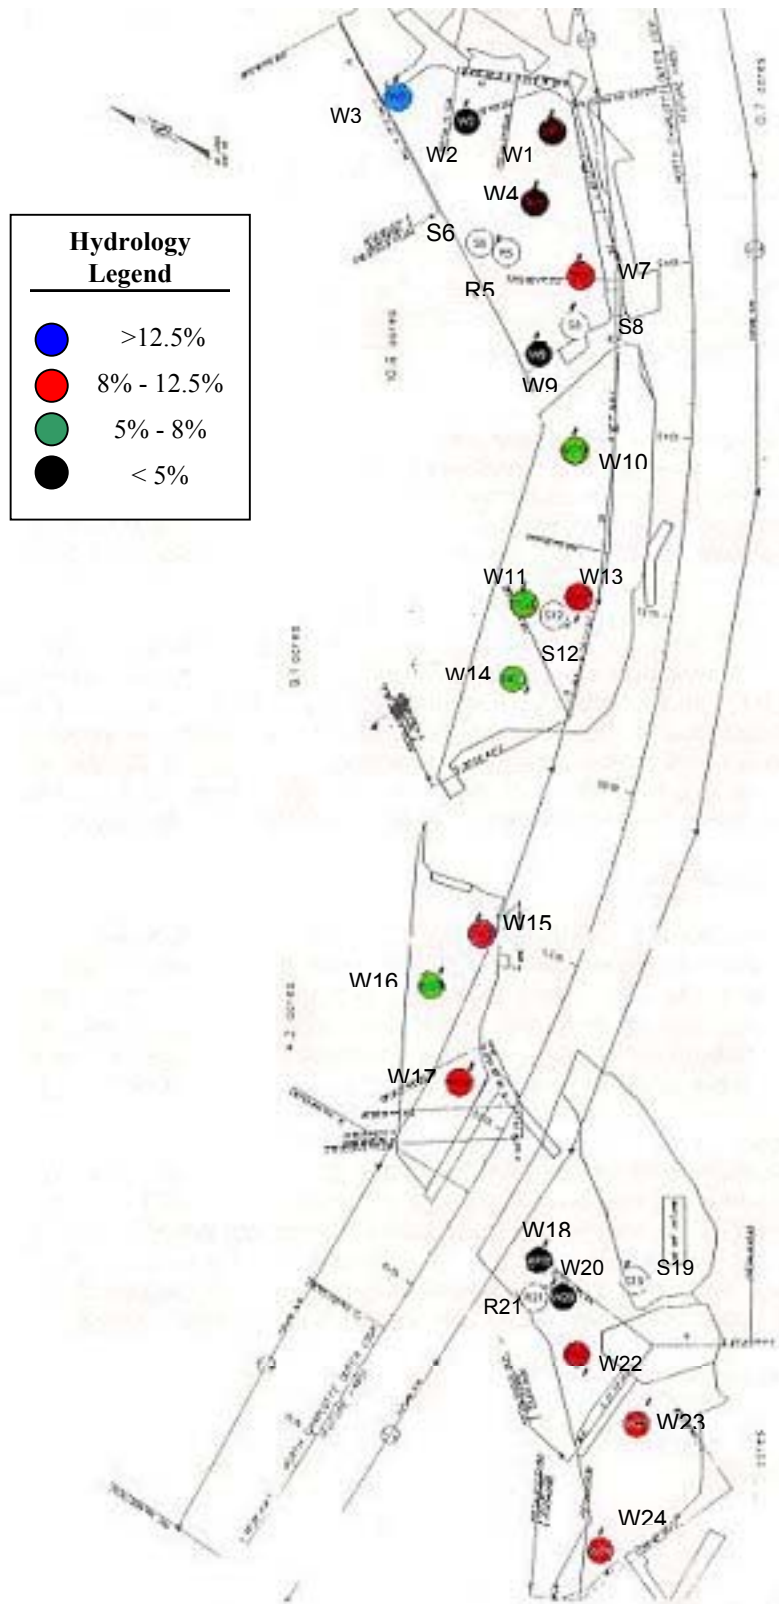
**Figure 3.** Long Creek Site 2002 Hydrologic Monitoring Results

The maximum number of consecutive days that the groundwater was within twelve inches of the surface was determined for each gauge. This number was converted into a percentage of the 235-day growing season. The results are presented in Table 2.

The placement of the groundwater gauges and a graphical representation of the hydrologic monitoring results are provided in Figure 3.

November and December 2001, February and April 2002 experienced below average rainfall. Along with the dry climatic conditions and several of the gauges experiencing malfunctions, the gauges at Long Creek experienced difficulty meeting success. One of the eighteen gauges showed saturation for 12.5% of the growing season, 7 of the gauges showed between 8 and 12.5% saturation, 4 of the gauges showed between 5 and 8%, and 6 of the gauges showed less than 5% saturation during the growing season.

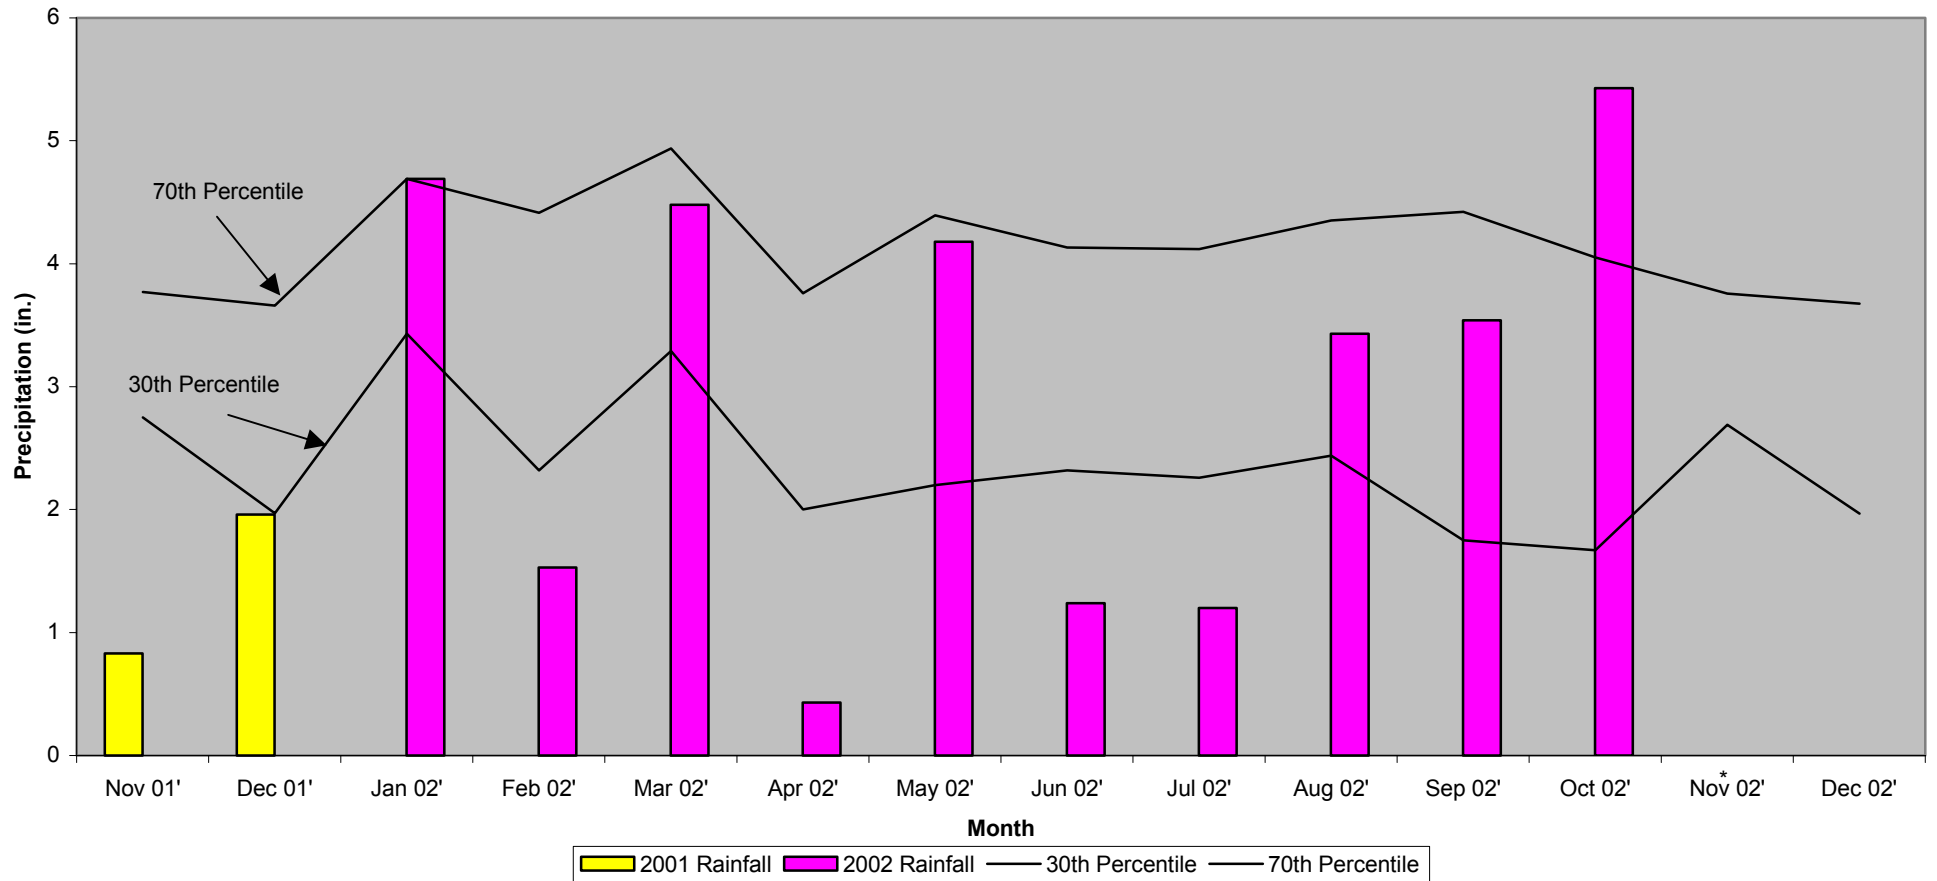
**Figure 4.**

Figure 4 is a comparison of the 2002 monthly rainfall to historical precipitation (collected between 1971 and 2002) for the Charlotte area. Rainfall data presented in the figure represents an average of the historical precipitation. It is assumed that, if the 2002 rainfall totals represented by bars fall between the average precipitation lines for each month, then the local climate was experiencing average conditions for that particular region. This comparison gives an indication of how 2002 relates to historical data in terms of average rainfall.

Months below the normal rainfall include February, April, June, and July. Months with normal rainfall include January, March, May, August, and September. The only month with above normal rainfall conditions was October. The site experienced below average rainfall for 2002.
